XVII. ENVIRONMENTAL REPORT EXCERPTS

March 20, 2000 Report:

Asbestos Survey and Assessment
Lead-base Paint Inspection
Drinking Water Sampling
Universal Hazardous Waste Report
Asbestos Management

UTAH STATE CAPITOL HILL COMPLEX STATE OF UTAH SALT LAKE CITY, UTAH

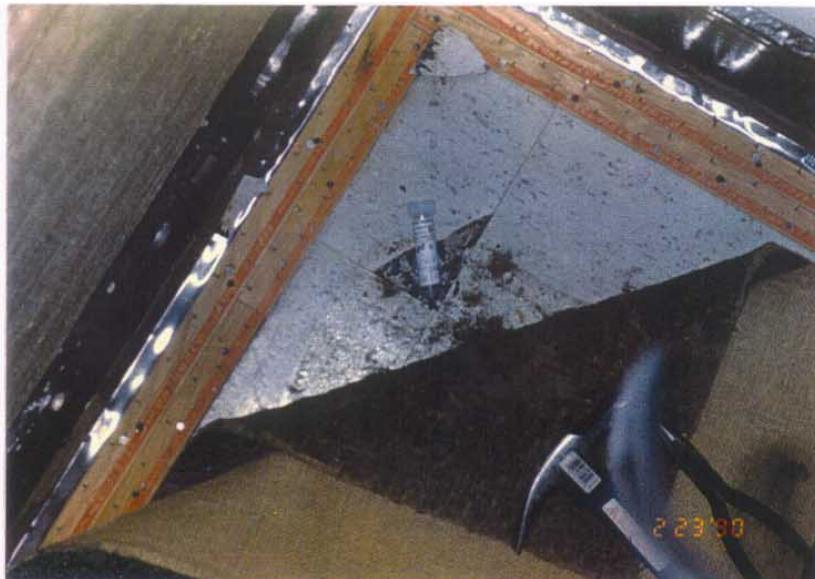
Photograph 1

View of the asbestos-containing 9-inch floor tile (M001). The black floor mastic (M001A) underneath also contains 15% Chrysotile asbestos.

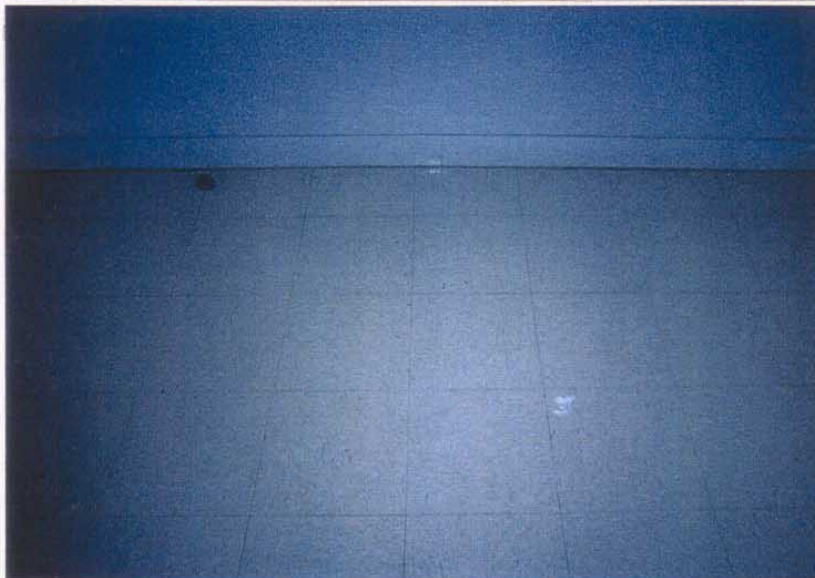
Photograph 2

View of the 12-inch non asbestos floor tile (M002). The black floor mastic contains >1% Chrysotile asbestos.

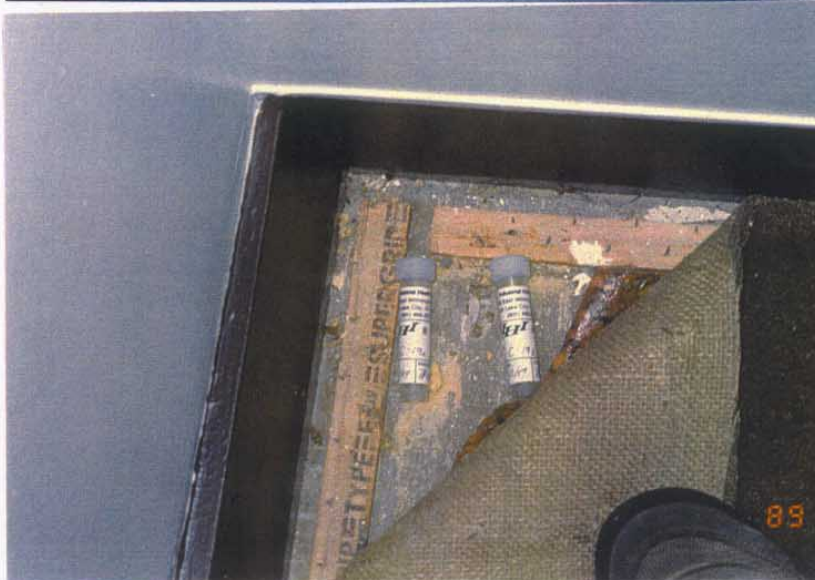
Photograph 3

View of the asbestos-containing 9" floor tile and mastic (M014).

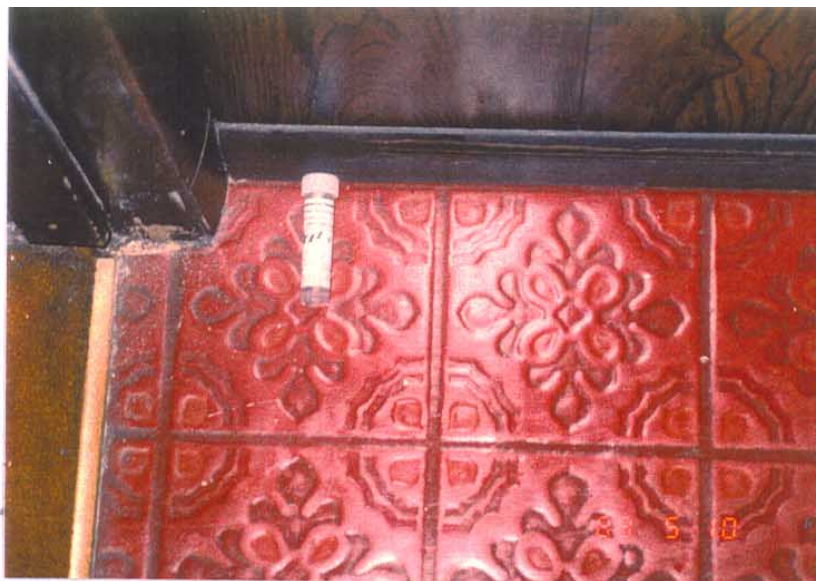
Photograph 4

View of the asbestos-containing red vinyl sheet flooring (M011). This area was not accessible at the time of the survey.

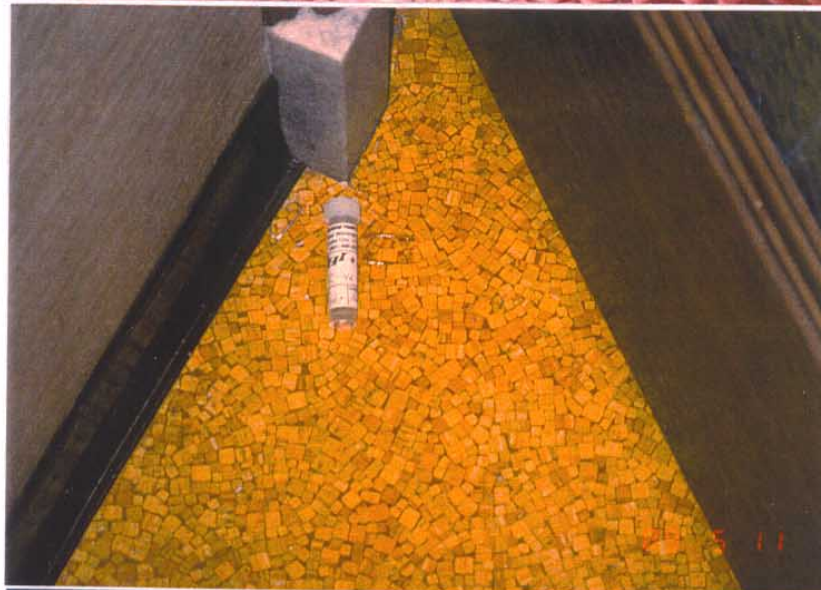
Photograph 5

View of the asbestos-containing yellow sheet vinyl flooring (M019)

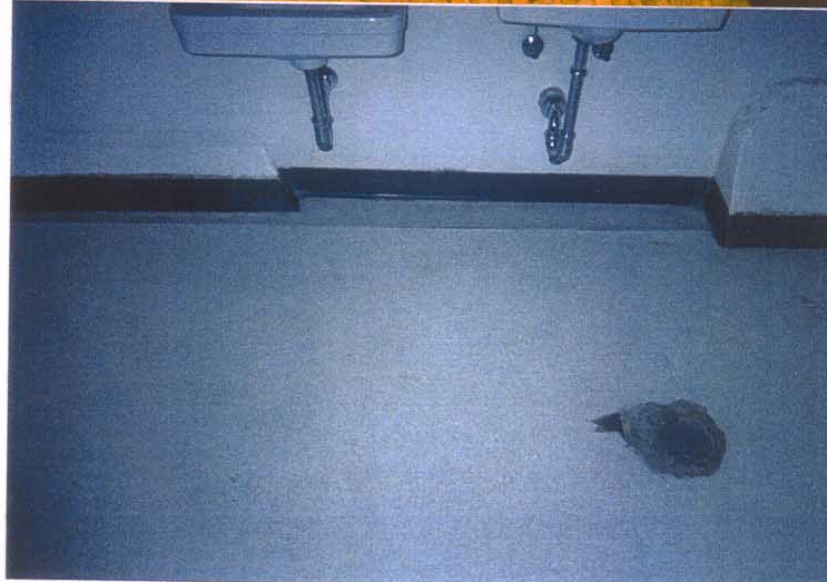
Photograph 6

This asbestos white vinyl sheet flooring in the men's locker room in the basement.

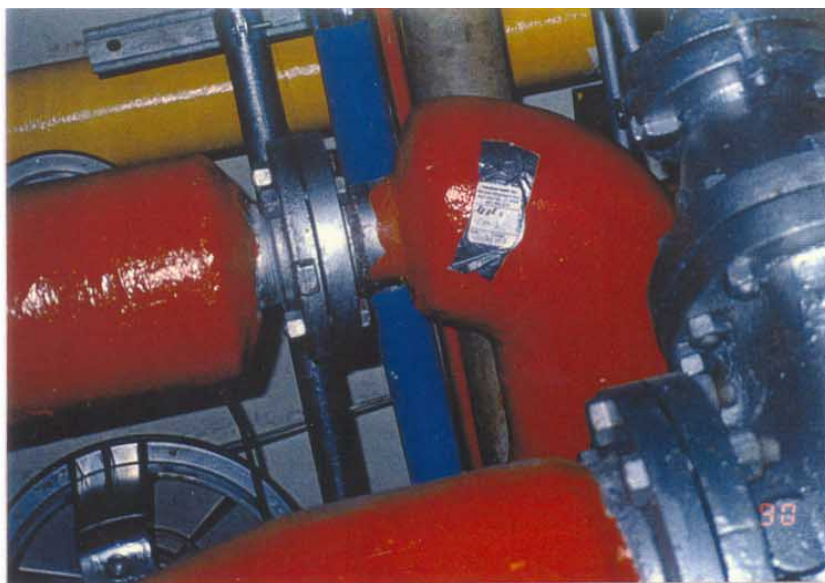
Photograph 7

View of the asbestos-containing pipe fitting insulation (T002)

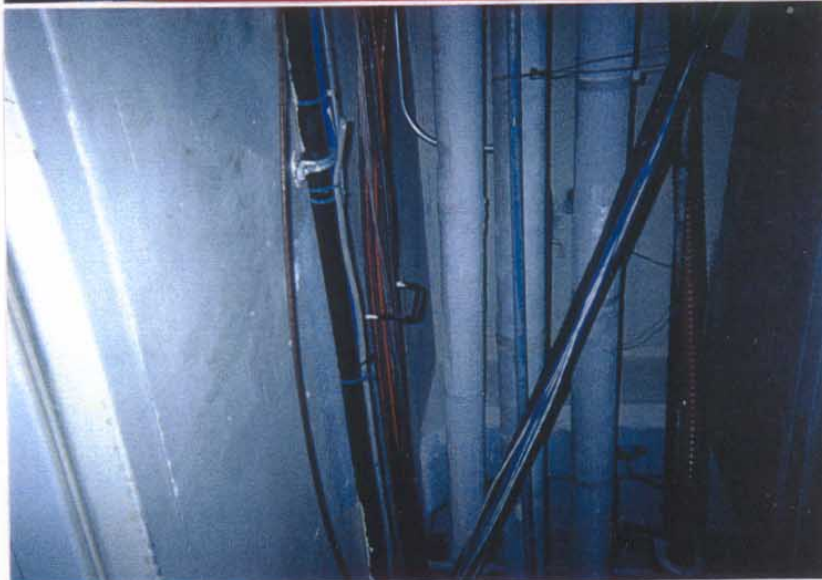
Photograph 8

View of the asbestos-containing aircell pipe insulation (T007)

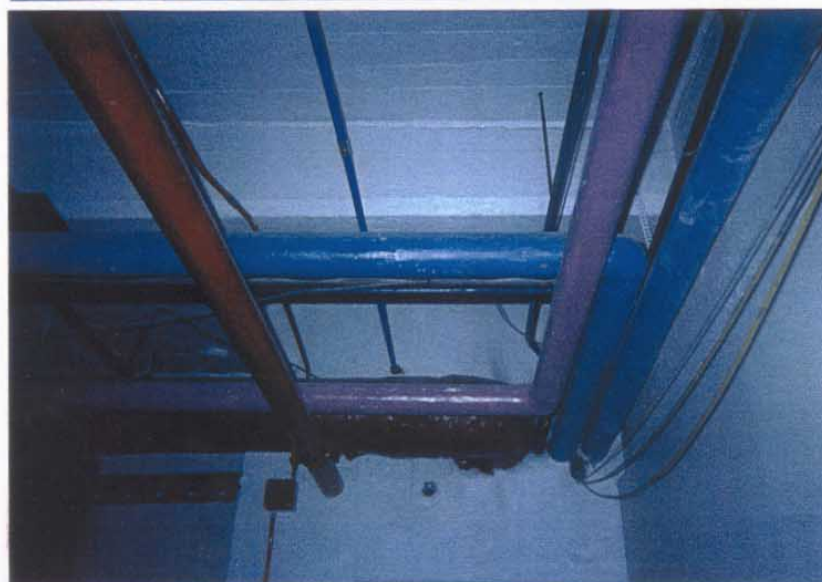
Photograph 9

T009	Pipe Insulation - White magblock insulation Basement: east section, n. entrance and N.W. section	12% Amosite 1% Crocidolite	275 ln. ft.	No Damage

View of the asbestos-containing magblock pipe insulation (T009).
